Slice Depth: 2.0-3.0 inch  
 Concrete Type: 123  
 Resolution: Normal  
 Collected: 2010-01-05  
 Analyzed: 2010-01-25

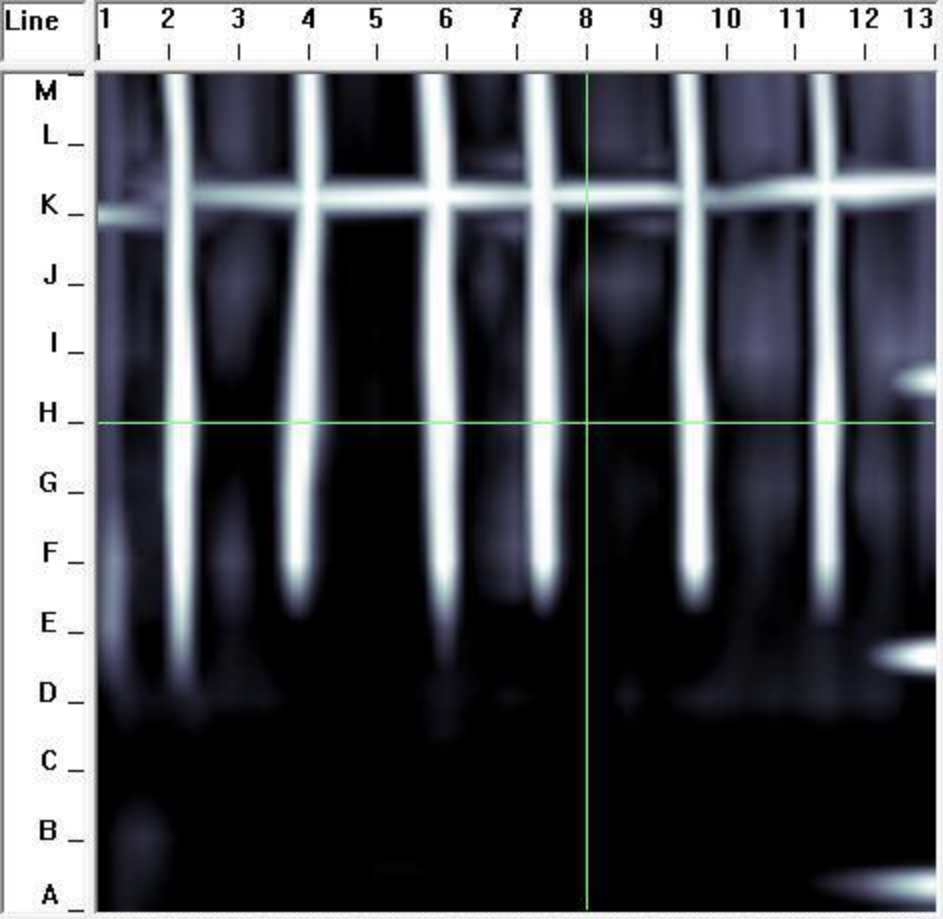
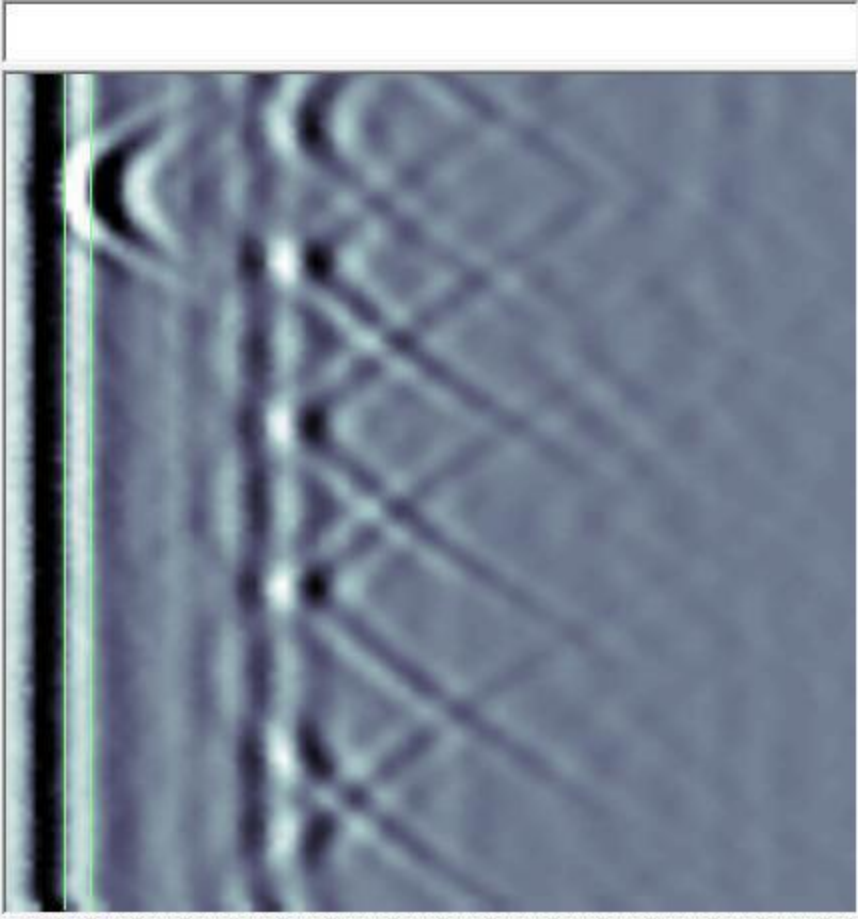
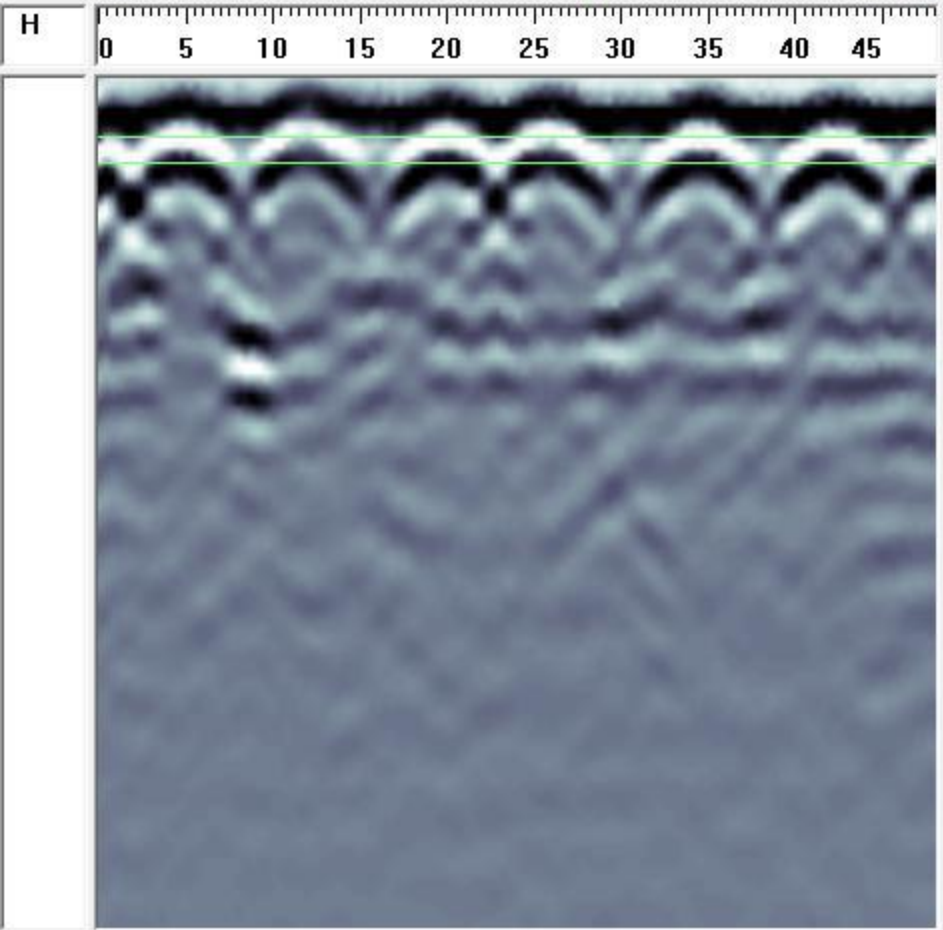
Slice showing top layer of rebar

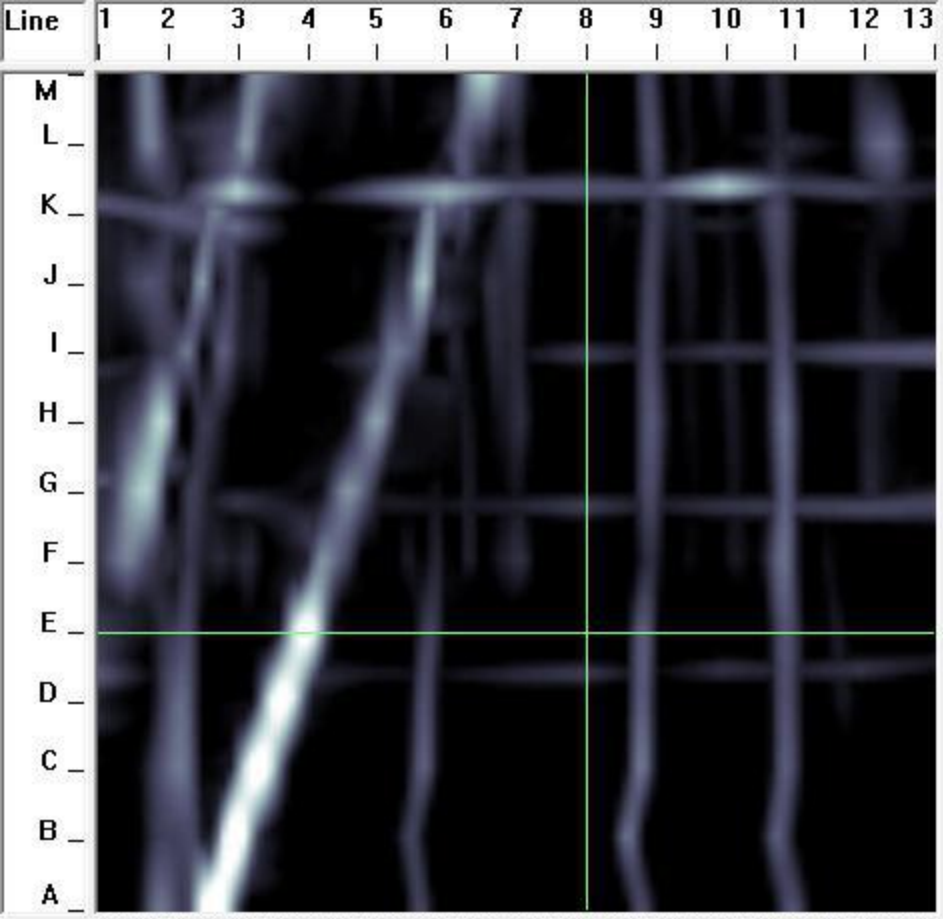
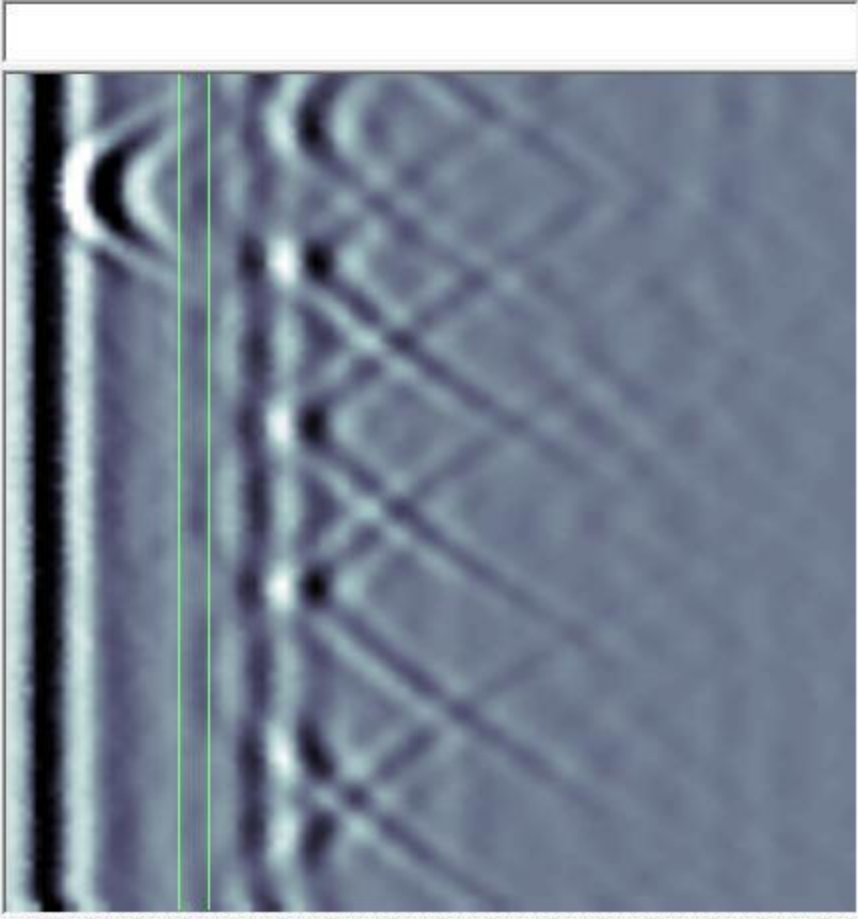
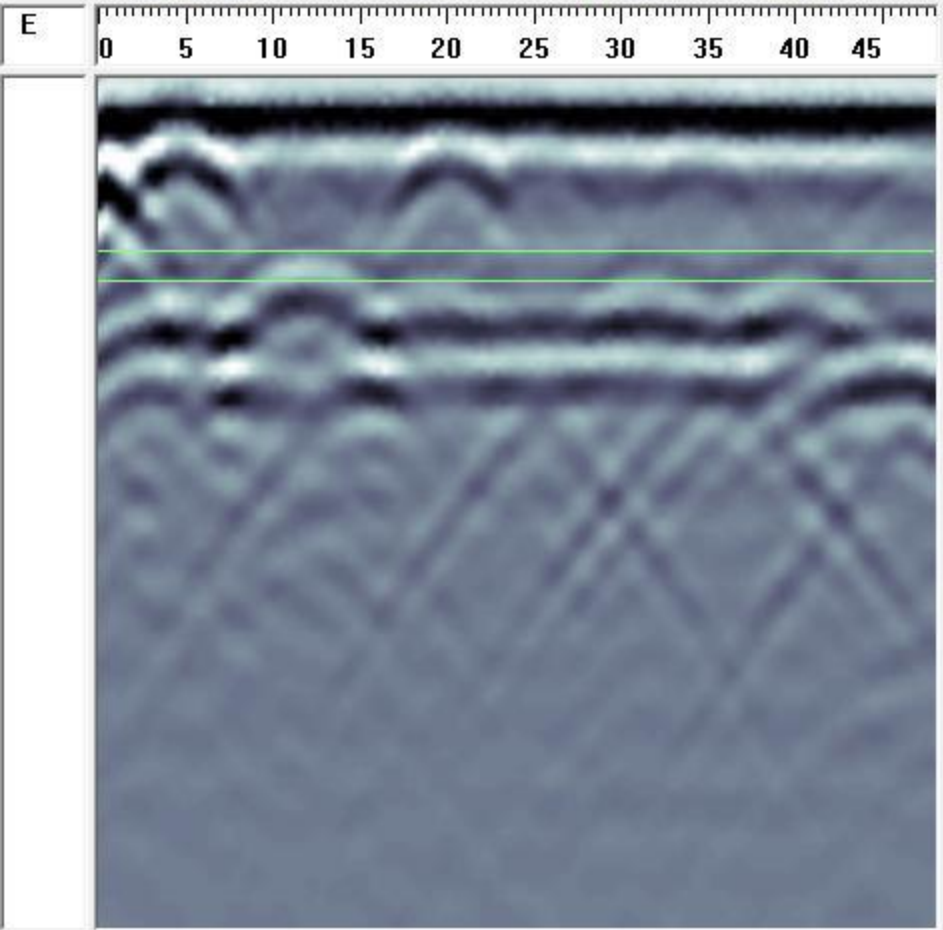
Slice showing 2 conduits

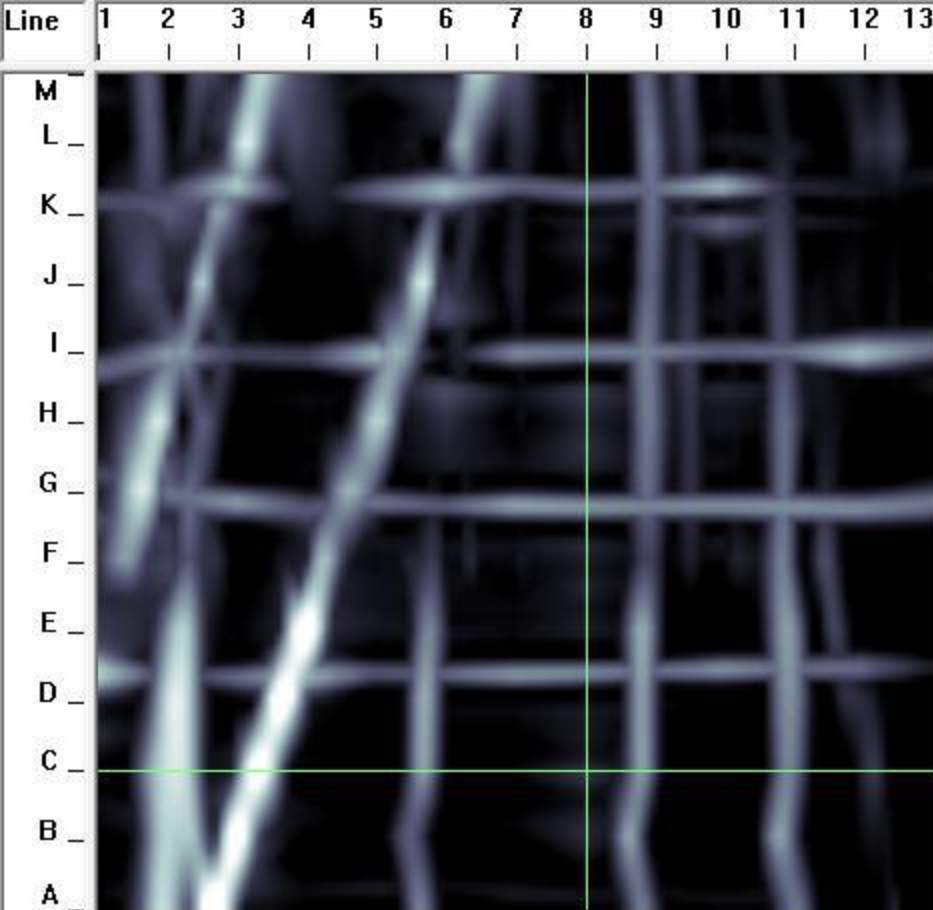
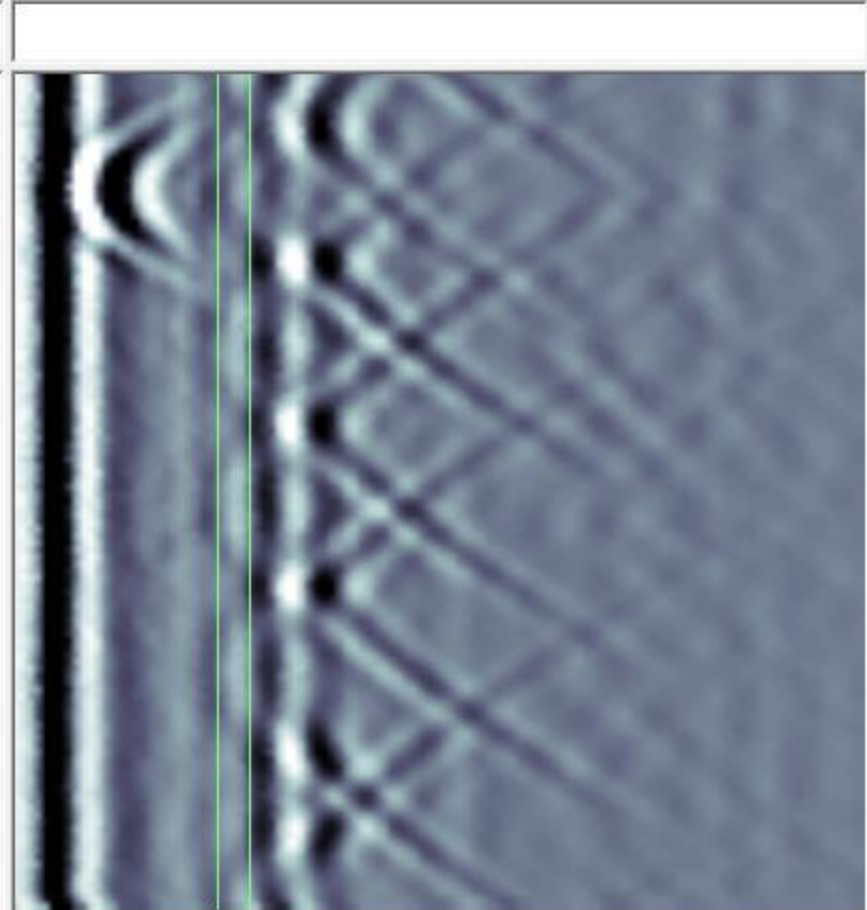
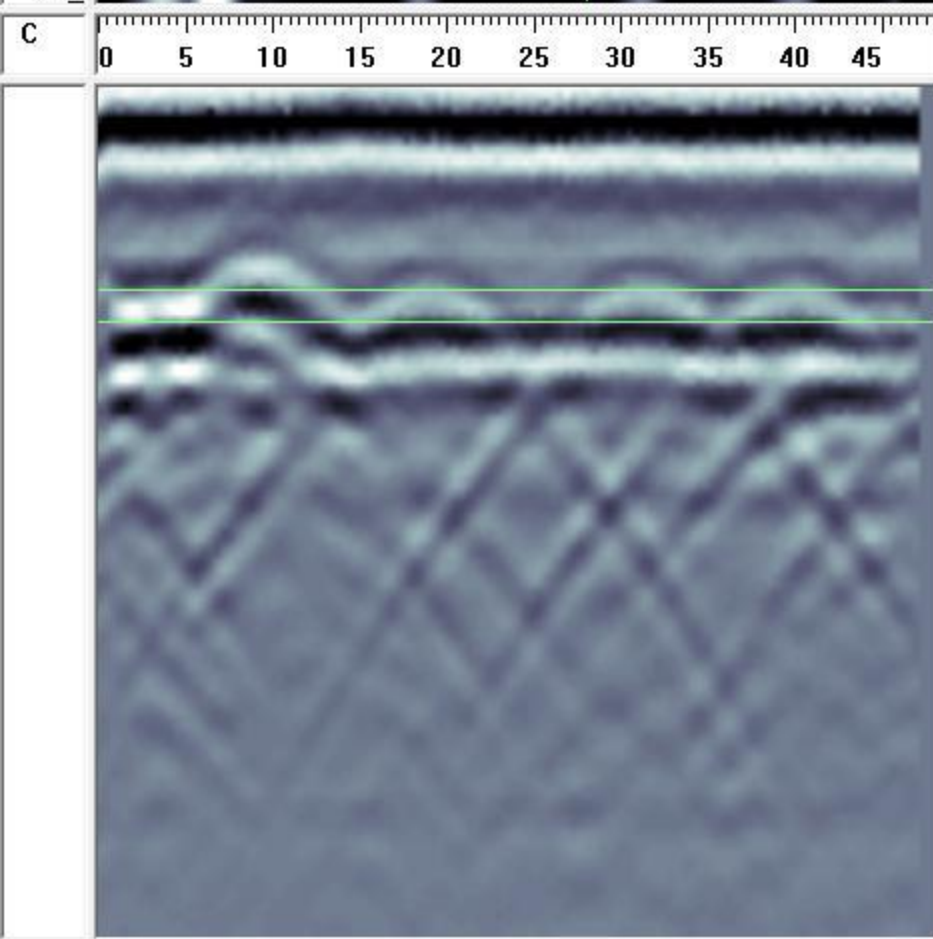
Slice showing bottom layer of rebar
